Mobile Intel[®] Celeron[®] Processor at 466 MHz, 433 MHz, 400 MHz, 366 MHz, 333 MHz, 300 MHz, and 266 MHz Specification Update

Release Date: October 2001

Order Number: 244444-027

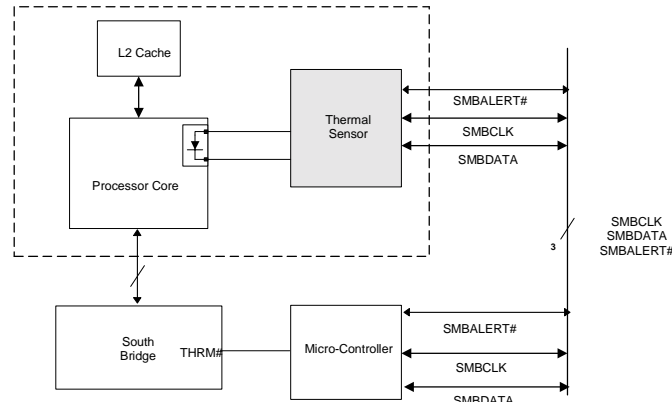
Figure 1. An Example of Microcontroller Driven Thermal Management

H29. Thermal Sensor May Assert SMBALERT# Incorrectly

Problem: The Intel Celeron Processor Mobile Module has a thermal sensor that monitors the processor core's temperature. Please note that desktop systems could have a similar thermal device. The thermal sensor asserts SMBALERT# if the processor temperature exceeds the temperature limits set in the Alarm Threshold Registers (T_{HIGH} , T_{LOW}). It also sets the corresponding Status Register bits to identify the cause of the interrupt. Figure 1 gives one example of the how the SMBALERT# signal could be used in a system.

Implication: There is no system impact from this erratum if temperature polling is used for processor thermal management. If the SMBALERT# interrupt is employed to manage processor thermal sensing, then servicing the false interrupt may result in premature system action depending on the software and hardware implementations used. The rate of the false interrupts is less than the auto-convert rate of the thermal sensor.

Workaround: Three different (mutually exclusive) workarounds are possible:

1. Before servicing an interrupt from the thermal sensor, read and compare the processor thermal reading with the threshold limits (T_{HIGH} or T_{LOW}). Figures 2 and 3 provide basic flowcharts for the implementation of this workaround in an interrupt driven system.
2. If the firmware implemented polls the Status Register only, then before taking any action, re-read the temperature register and do a comparison with the alarm threshold limits (T_{HIGH} or T_{LOW}) to determine if the value is actually still within the temperature window.
3. Use a temperature polling scheme to monitor the processor temperature.
